MISCELLANEOUS PAPER GL-79-20

**VISIT TO JAPAN TO OBSERVE DAMAGE
WHICH OCCURRED DURING THE NEAR
IZU OSHIMA EARTHQUAKES
JANUARY 14 AND 15, 1978**

William F. Marcuson III

August 1979

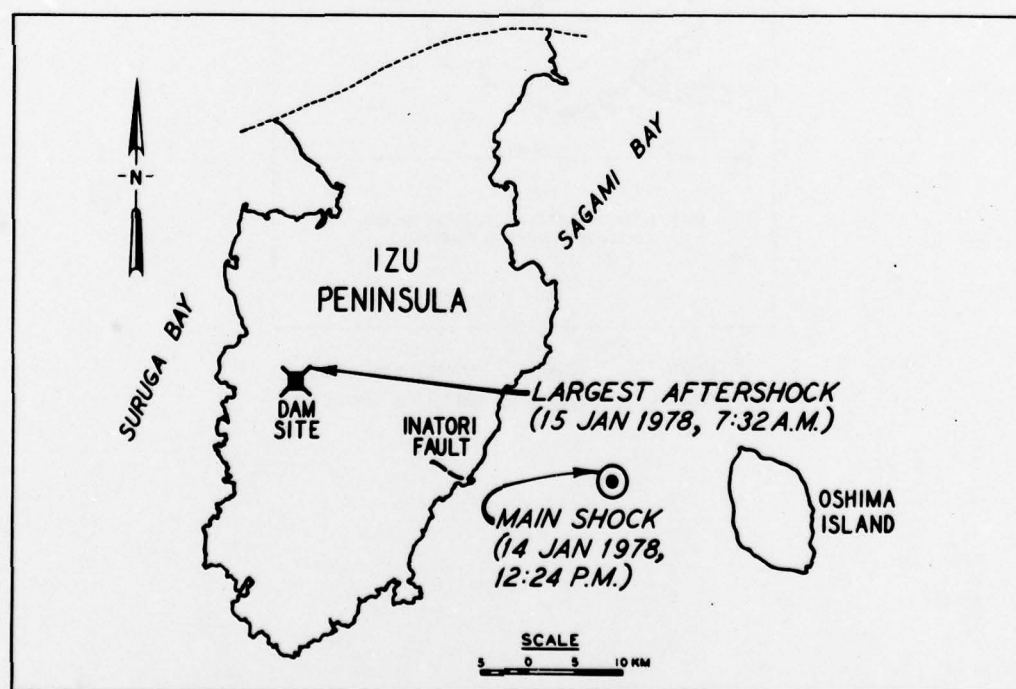
Figure 5. Map of Izu Peninsula with epicenters superimposed

latitude 34° , $38'$ and longitude 130° , $18'$ east. This epicenter is shown in Figure 5. Figure 6 is a drawing of the Izu Peninsula. The epicenters of earthquakes occurring between 10:38 p.m. on 13 January and 12:23 p.m. on 14 January are superimposed on this plot. Hindsight tells us that these small earthquakes were foreshocks to the main event. Figure 7 (a similar plot to Figure 6) shows the epicenters of earthquakes which occurred between 12:24 p.m., 14 January, and 11:59 p.m., 14 January. The large circle represents the main shock. Figure 8 is a plot of epicenters of earthquakes which occurred on 15 January. The large circle is an epicenter of the largest aftershock (magnitude 5.7), which occurred at 7:32 a.m. Japanese Standard Time on 15 January. Figure 9 is a plot of epicenters of earthquakes which occurred on 16 January. Figure 10 is a plot of all the epicenters of earthquakes which occurred between 10:38 p.m., January 13, and 11:59 p.m., January 16. The open circles are foreshocks, the solid circles are aftershocks, the double circle is the main shock, which occurred at 12:24 p.m., 14 January, and the solid circle with a cross is the largest aftershock, which occurred on January 15 at 7:32 a.m. From these figures (6-9) it is apparent that the stress release was taking place in a westerly direction, i.e. the epicenters moved from east to west with time.

11. During the main shock the Inatori Fault, shown in Figure 5, was subjected to right lateral movement. The maximum offset on the Inatori Fault was about 18 cm; Figure 13 shows photographs of this 18-cm offset along the Inatori Fault as it crosses a highway in the town of Inatori. Various Japanese engineers and scientists reported horizontal movement of as much as 60 cm; however, no displacements larger than 18 cm were actually observed.

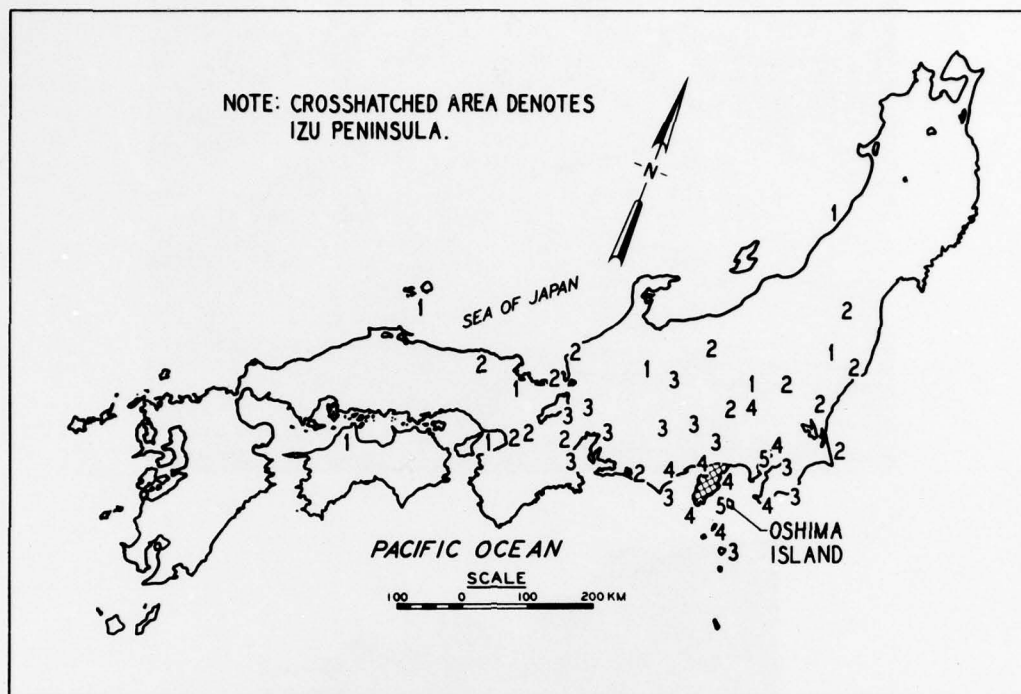
Figure 14. Map of Japan with JMA intensities superimposed

12. Figure 14 is a map of Japan. The Izu Peninsula has been crosshatched for easy identification. Also shown on this map are numbers indicating Japanese intensity values. These values are Japanese Meteorological Agency (JMA) seismic intensity values and not Modified Mercalli values. In general, the JMA intensity 5 would correspond to a Modified Mercalli VII or VIII. Figure 16 is an enlarged view of the Izu Peninsula. Superimposed on this figure are two horseshoe-shaped curves indicating the areas in which most of the damage occurred. The interior horseshoe represents the area of most extensive damage with less damage occurring around the periphery of the interior curve but within the bounding curve. Estimates of peak acceleration in the interior curve are about 400 gals ($4/10$ g) and within the overall damaged area about 300 gals ($3/10$ g). These estimates are based on calculations made from the dimensions and weight of tombstones that did and did not overturn. This earthquake caused about one hundred million dollars damage to property and killed 25 people. Most of this damage occurred to highways as a result of landslides and rockfalls and most of the people were killed in houses located below the landslides and in vehicles which were traveling along these highways during the earthquake.

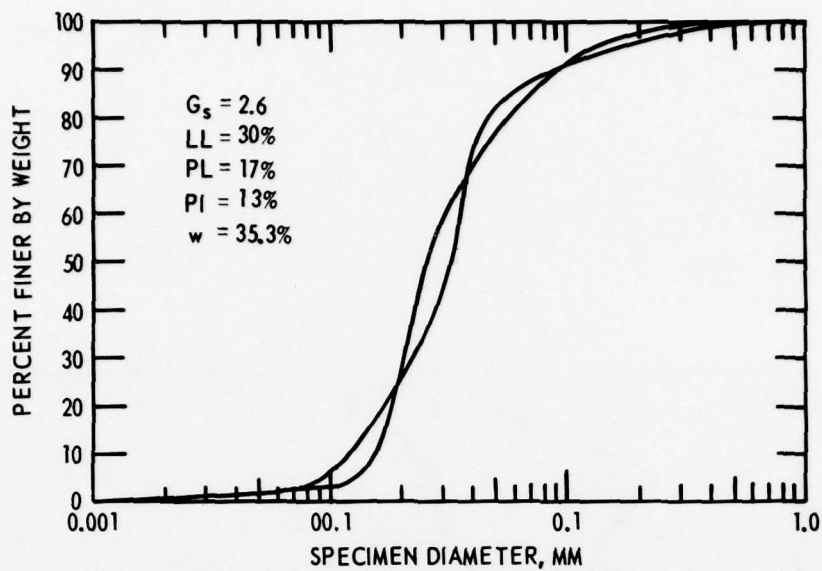
Figure 24. Gradation determined by Japanese

23. Figure 24 is a mechanical analysis of the tailings material which was obtained from the Japanese. The material falls generally between 0.01-mm- and 0.1-mm-diameter sizes. According to the Japanese, the specific gravity is 2.6, the liquid limit is 30 percent, the plastic limit is 17 percent, the plasticity index is 13 percent, and the water content is 35 percent. Figure 25 shows the results of a sieve analysis which was conducted on tailings material at the WES. Also shown on this plot are the Atterberg limits that were obtained at WES. Note that there is a discrepancy between the limits obtained in Japan and at WES.
